Land Rover
Rover 3.5 litre
V8 Engine Head Rebuild

May 2012

To confirm and then resolve a problem causing the engine to burn excessive oil especially when first started resulting in a substantial plume of unpleasant blue smoke.

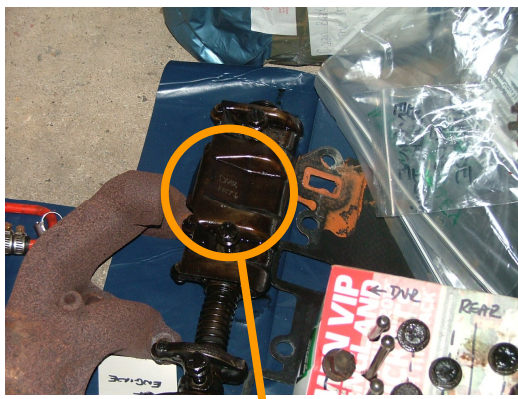
Splash shield marked DVR-FNT ↓
The arrow points to the front of the engine

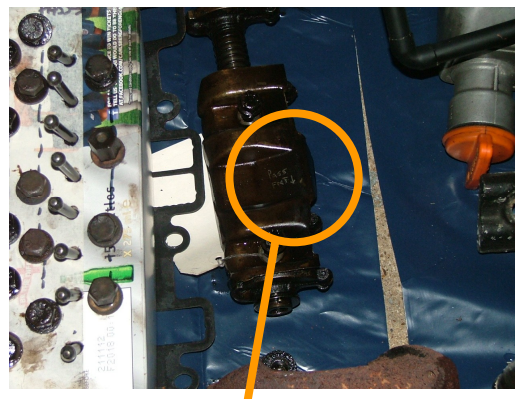
Splash shield marked PASS-FNT ↓
The arrow points to the front of the engine

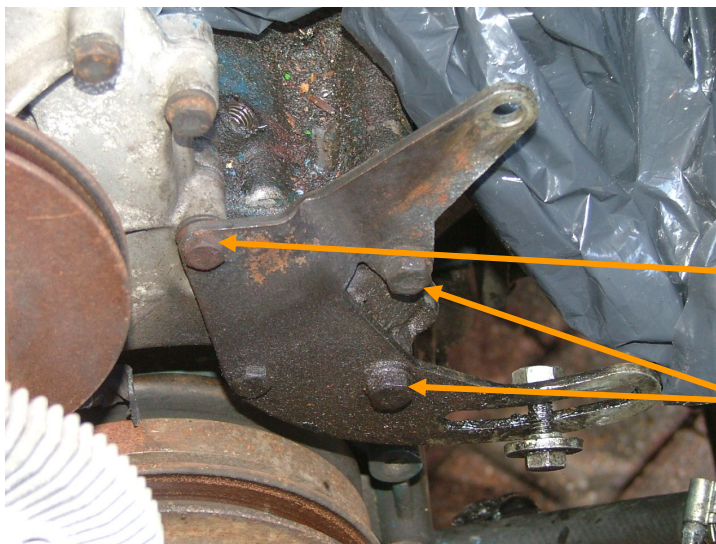
The pump was in ok condition, but is grubby and a little corroded, so it's no bad thing to replace it. Some pictures here show the bolt patterns (the bolts are all in a card holding the placements)

This pic shows the power steering bracket on the passenger side of the water pump. All four bolts fixing the bracket are water pump bolts. Note that this bolt into a nut at the back of the water pump.

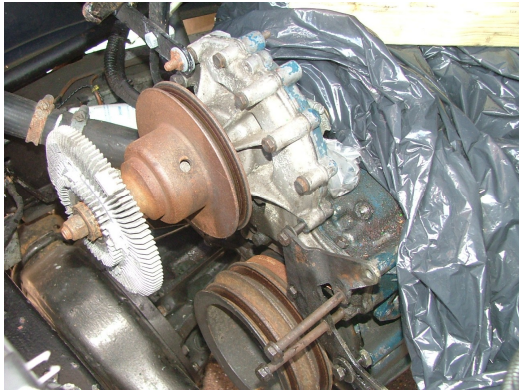
The two pic's below show the water pump bolt pattern from the top. Note the bolt and nut referred to above can be seen in both shots (with the nut laying nearby)

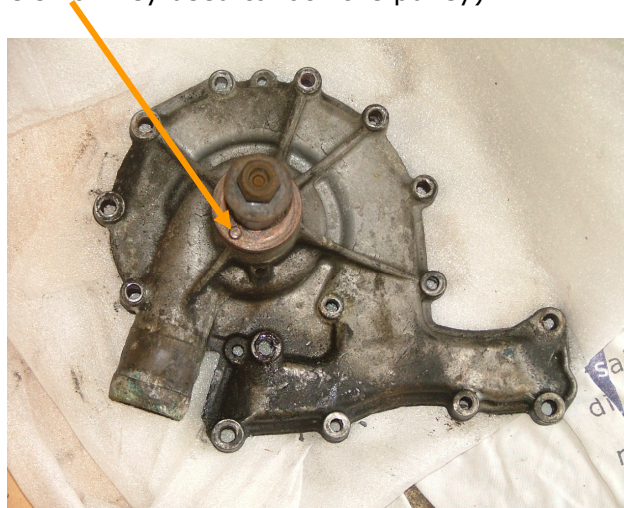
And finally with the pulley removed, the specifics of the water pump shaft can be seen (including the small key used to lock the pulley).

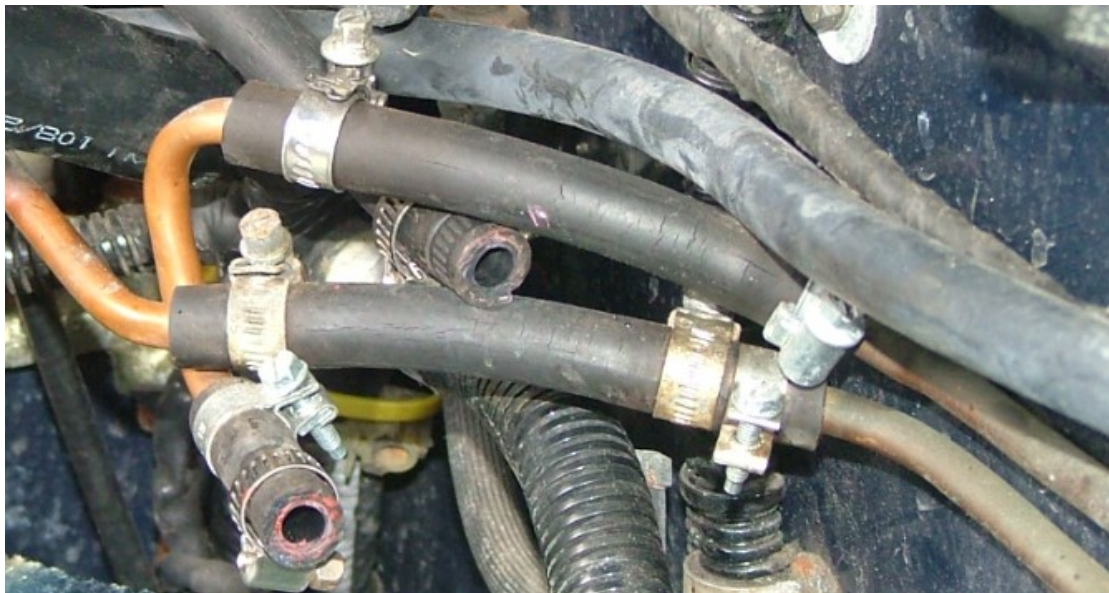
One thing I did find interesting is that the existing short straight section of hose pipe on the flow and return sides of the fuel lines were both lightly but noticeably cracked – as you can clearly see in this picture.

These are not old hoses and they are also DIN rated fuel injection hoses – so it was a little surprising. They have all now been renewed (and because of the new manifold, they will all be straight)

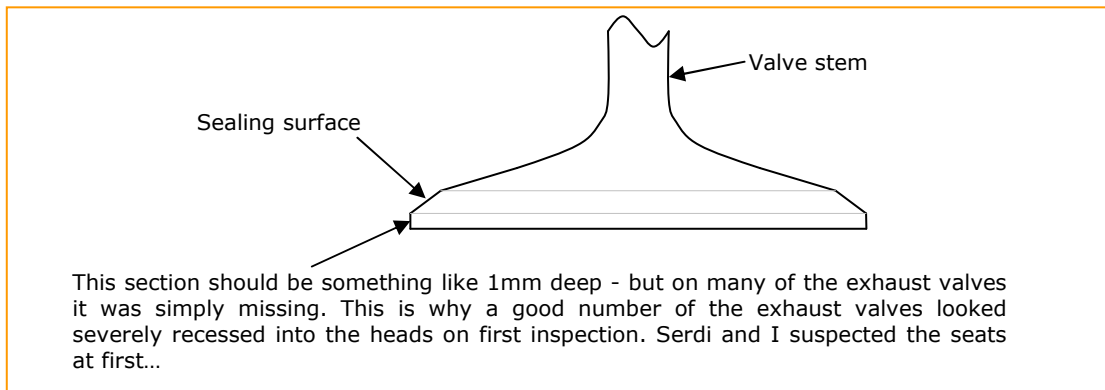
3. The valves fitted in the engine were the original Rover parts and all were significantly worn. Surprisingly however it wasn't the stem-to-guide clearance that was the main problem – instead it was the area around the seat sealing surface...

The two heads are definitely fitted with hardened valve seats – and in fact Rover heads have been fitted with hardened seats ever since 1972 which makes sense given the engine was being sold in the US. However, a head using unleaded fuel needs hardened valve seats AND hardened valves – and after inspecting the valves it is extremely unlikely that these heads were fitted with hardened valves (Land Rover used the cheaper valves for the UK market). The resulting valve wear accompanied with little or no seat wear supports the explanation that it was the combination of unleaded fuel and inappropriate valves that may have been responsible for the significant wear.

Regarding the wear – and just as a note, unleaded fuel and the linked valve seat wear problem is always confined to the exhaust valves, because they run at such high temperatures compared to the intake

Across all 16 seats only one needed to be replaced (with a hardened part). Also all the valves were replaced with a new set of best quality valves (chrome finish, tufrided + wafer tip) – and which are off course hardened for unleaded fuel

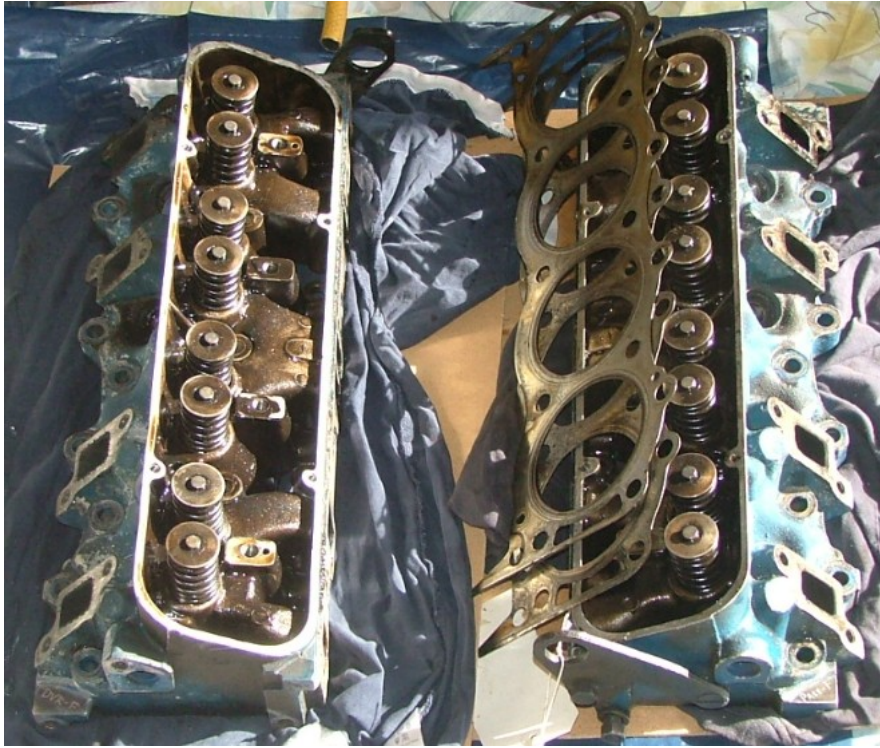
These are the old heads as they came off the engine...

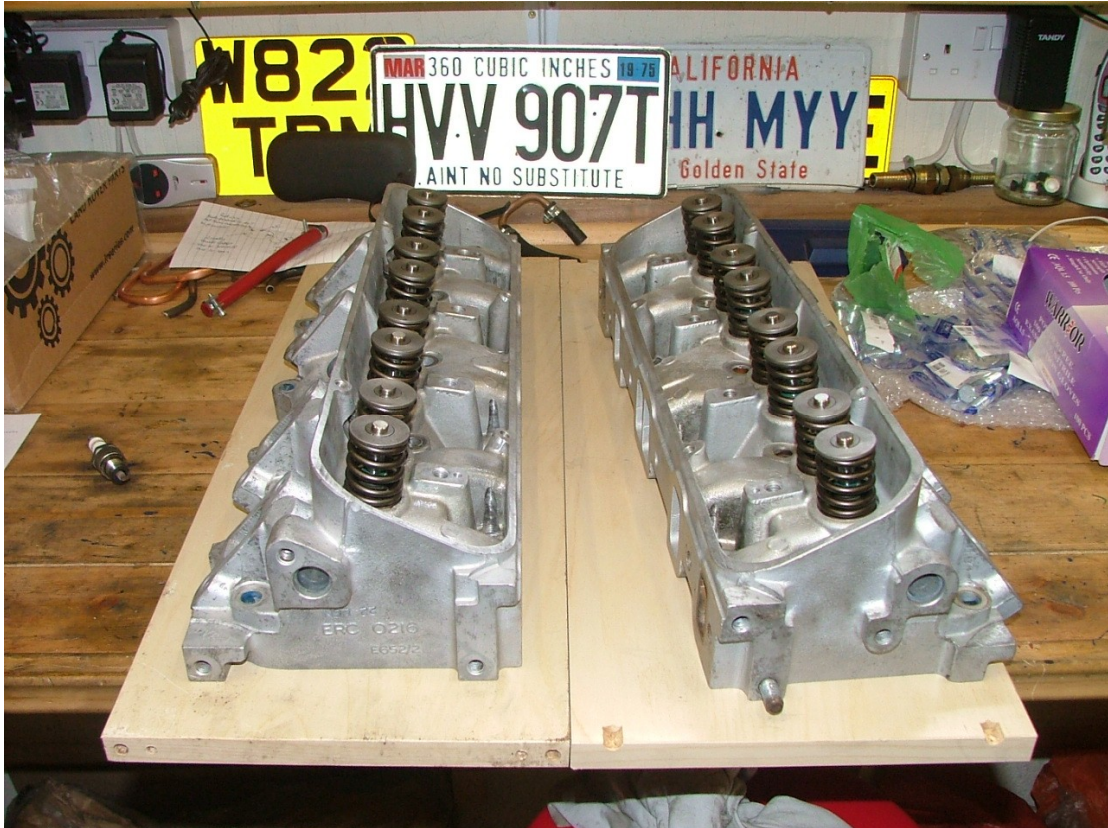
After Serdi's work here is the result (before I paint them)

1. The heads were hot tanked (all paint and deposits removed).
2. The old valve guides were all worn and original, and were consequently all tight in their interference fit bores in the head (which is good because it means they definitely hadn't been physically ripped out (ie: the wrong way) at any time in the past – a common fault and the cause of many a Rover burning oil due to scored guide bores allowing oil to drain. Mathew was forced to drill all 16 guides out of the head the proper way).

Guide to valve stem wear was well over 2 thou on each guide. They were all replaced with the newer, later brass types and the upper section of each was prepared so that they could accommodate proper oil seals (which are now fitted).

4. All springs were replaced (the collets and locks are original)
5. The two heads were skimmed – one needed roughly 6 thou to be removed but the other needed 12 thou in order to flatten and correctly balance the compression ratio of both heads. Either way the compression will lift slightly from the very low 8.13:1.
6. The chamber volume of the head after the rework was measured as: 34.25cc

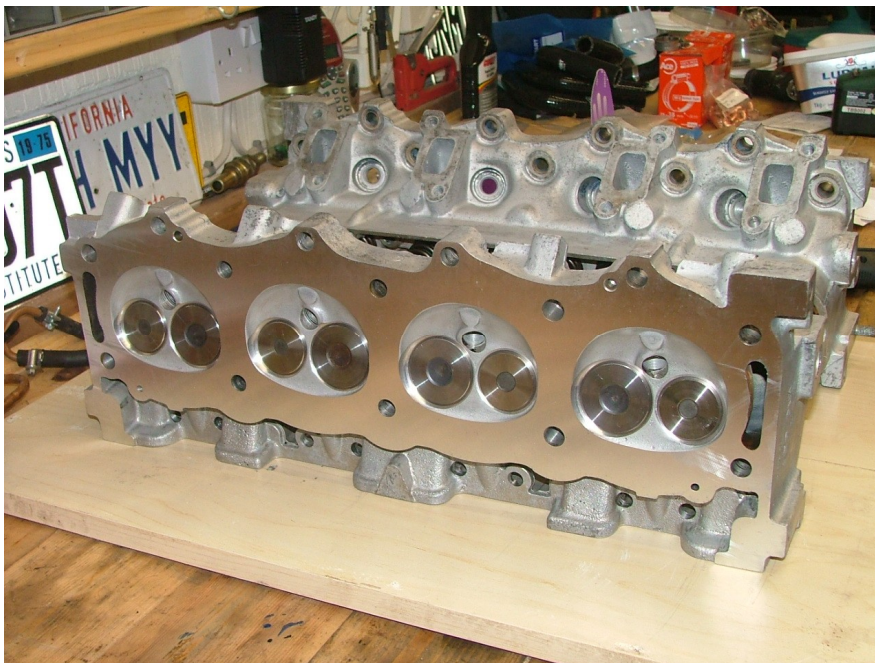
The view looking at the skimmed surface

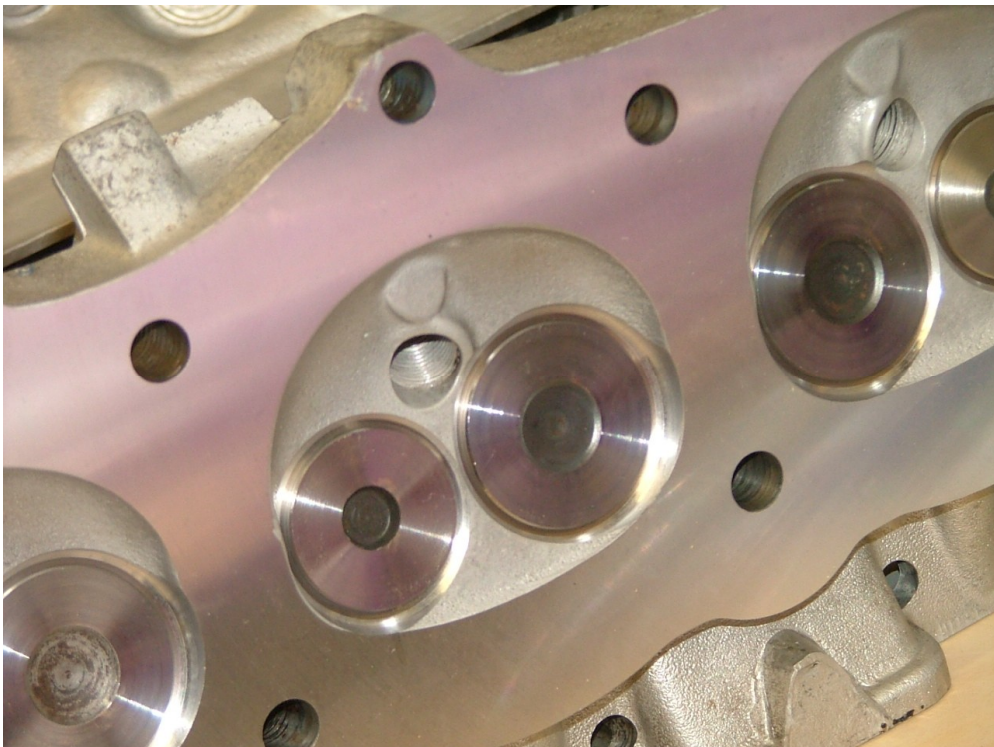
...Next the passenger side head (the colouring is a reflection of my red T shirt)

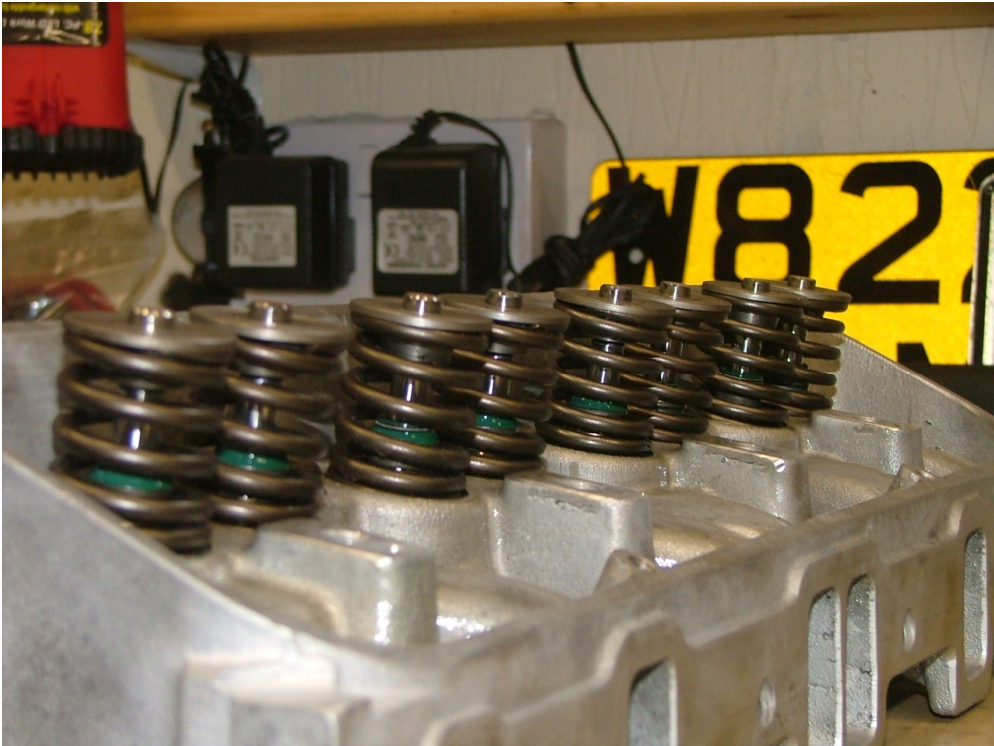
View showing the new oil seals and the tops of the valve stems. A straightedge can be placed along the tops of these valves, leaving no gap.

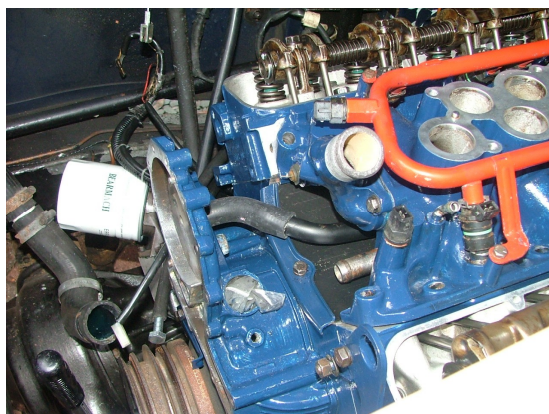
Looking at the S pipe during mock up (no jubilee clips) you can see how this new pipe works. Note the feed pipe will be connected by soft hose and is formed from the hose with part number ERC 2319 but cut more or less in half (its actually slightly longer than one half).

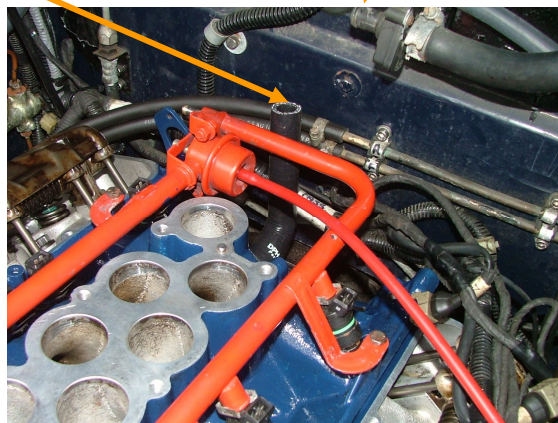
At the back of the manifold – the new 19mm to 16mm right angle can be clearly seen – and it is lying neatly under the sluice valve.

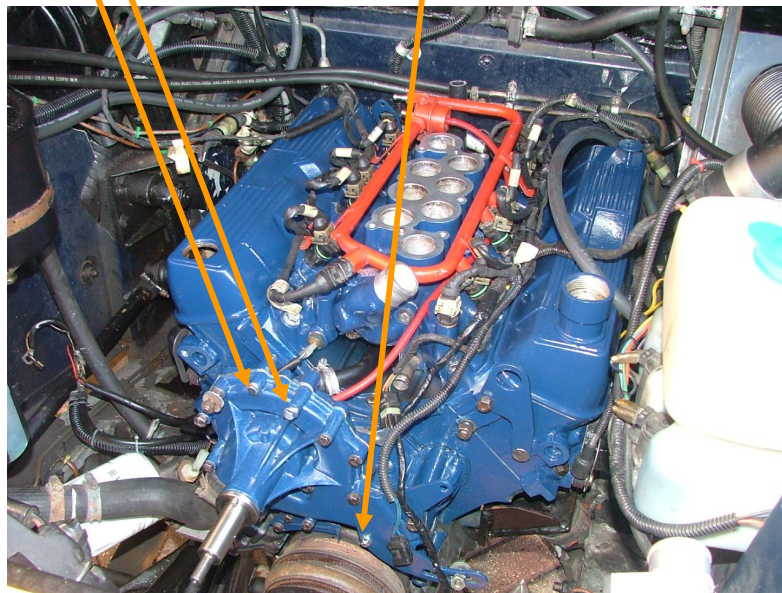
Hole in timing cover retapped M6 and fitted with a threaded stud and with a nut/washer on outside.

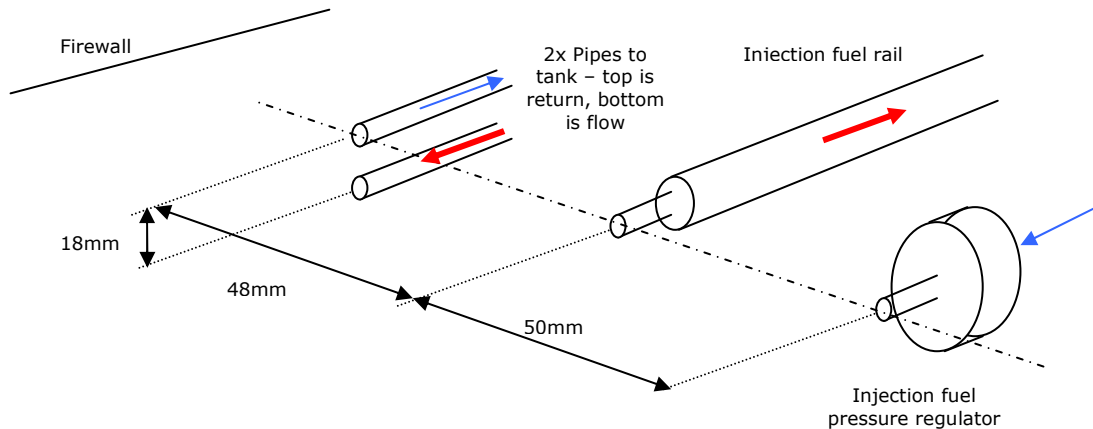
Pictorially this is the problem we had to solve...

The two brass fuel lines fixed to the firewall and which supply and collect fuel to/from the tank are shown at the top. Both brass pipes have now been cut flat (to remove the old angled kick out) and they are mounted with a vertical separation of roughly 18mm. The return tank pipe, and the two connections at both ends of the fuel injection rail are horizontally on the same plane – and each of the three pipes is separated by 50mm.

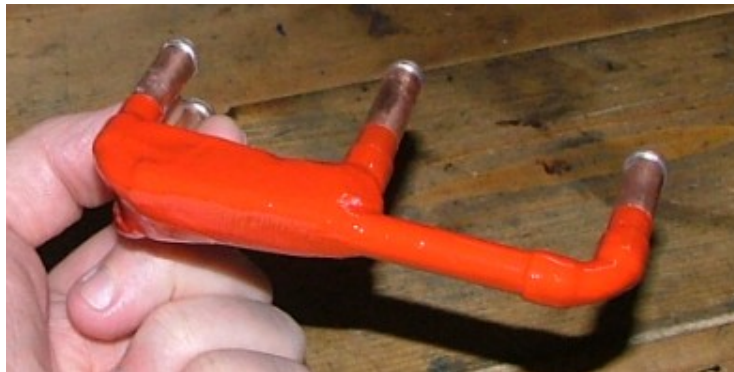
The manifold as constructed (and as it would connect to the diagram above) looks like the following.

Effectively we needed a U bend to connect the tank return to the injection rail return, and a smaller but also bent U bend (offset by 18mm) to connect the tank flow to the injection rail flow line. It was constructed in 9mm copper using soldered preformed 9mm bends. The two U pipes are soldered together and then further secured by embedding in a small block of epoxy metal resin for strength – and each of the four union ends also were given soldered lips.

The resin does look a little rough simply because it was very difficult to smooth it out flat – even after filing and sanding. Regardless, the manifold is strong and I think will definitely make those fuel connections tidier and safer while also shortening both connection hoses. The assembly now has one coat of spray primer and two coats of red top coat (to match the fuel injector rail of the intake manifold).

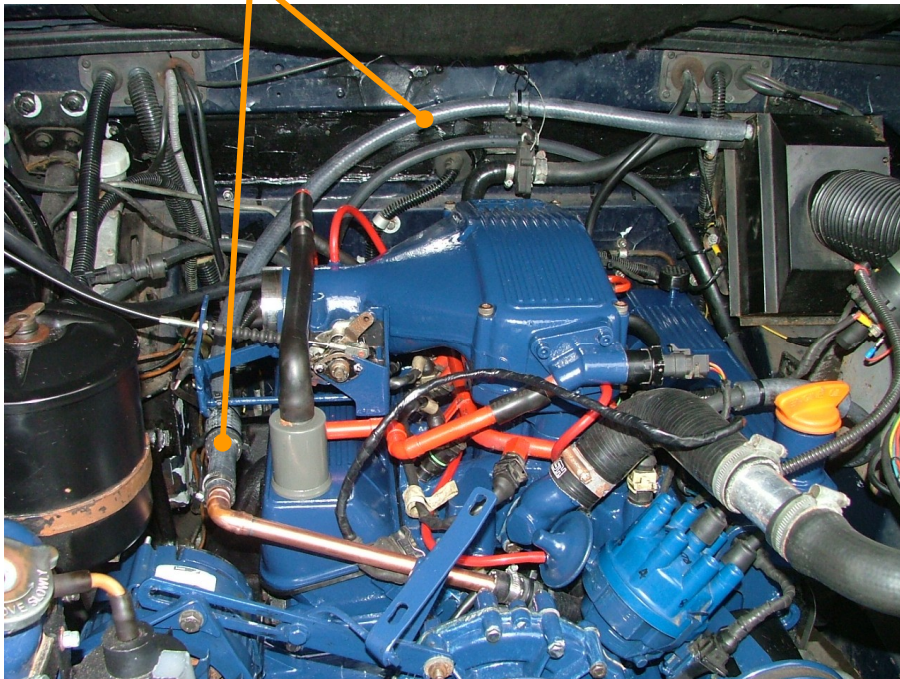
This picture shows the route taken by the 16mm hose to feed the heater matrix

Note the tied support to the hose on the firewall. The hose itself wasn't in my stock (the only 16mm hose I have is the shiny black hose suited to very high pressure hydraulic oils – and which I use on the PAS). But after phoning Keith Gott, I spoke to a company called FRM in Aldershot. They have a web site at www.frmspares.co.uk and although they actually specialise in heavy commercial vehicles (dealing with things like props, huge UJ's and springs etc) they did indeed have 16mm ID coolant hose, and I got a good price and 3.5mtrs for the
